DEPARTMENT OF TRANSPORTATION**DIVISION OF ENGINEERING SERVICES**

Contract #: 04-0120F4Cty: SF/ALA Rte: 80 PM: 13.2/13.9File #: 1.28**WELDING INSPECTION REPORT****Resident Engineer:**Siegenthaler, Peter**Address:** 333 Burma Road**City:** Oakland, CA 94607**Report No:** WIR-022410**Date Inspected:** 05-Apr-2011**Project Name:** SAS Superstructure**OSM Arrival Time:** 700**Prime Contractor:** American Bridge/Fluor Enterprises, a JV**OSM Departure Time:** 1530**Contractor:** American Bridge/Fluor Enterprises, a JV**Location:** Job Site

WELDING INSPECTION REPORT

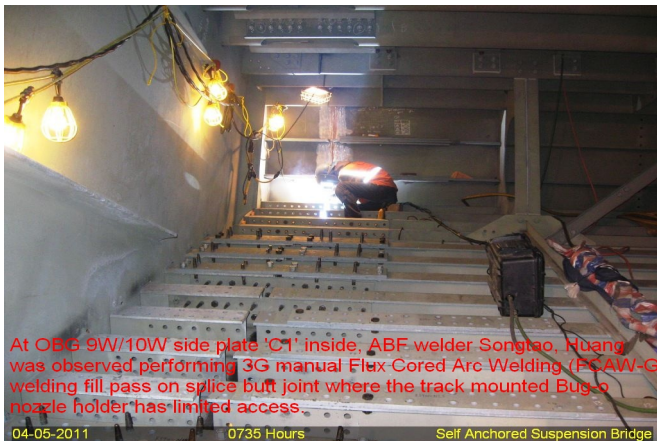
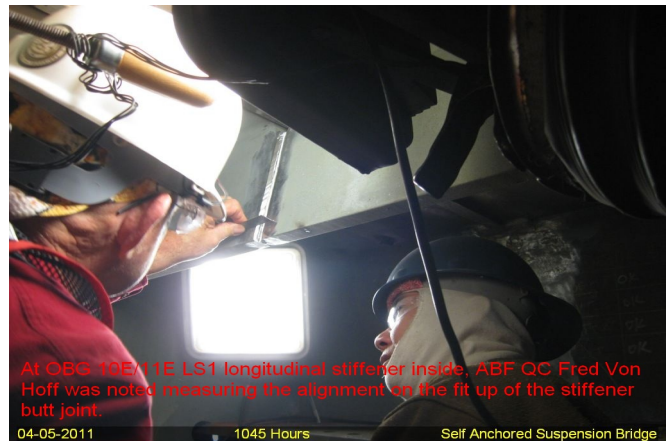
At OBG 9W/10W side plate 'C1' (0mm to 1000mm) inside, QA randomly observed ABF/JV qualified welder Sungtao, Huang ID # 3794 continuing to perform CJP groove (splice) welding fill pass to cover pass on the splice butt joint at the corner with edge plate 'B' where the track mounted Bug-o nozzle holder has limited access. The welder was observed perform manual welding in the 3G (vertical) position utilizing a dual shield Flux Cored Arc Welding (FCAW-G) with E71T-1M, 1/16" diameter wire electrode and implementing Caltrans approved Welding Procedure Specification (WPS) ABF-WPS-D15-3042B-1. The joint being welded has a single V-groove butt joint with backing bar. During welding, ABF Quality Control (QC) William Sherwood was noted monitoring the welding parameters of the welder. At the end of the shift, cover pass welding at location mentioned above was completed and the welder informed this QA that he is moving to 10E/11E side plate 'C' inside for his next welding location.

At OBG 10W/11W edge plate 'B' inside, QA randomly observed ABF/JV qualified welder Fred Kaddu continuing to perform fill pass to cover pass back welding on the Complete Joint Penetration (CJP) splice butt joint. The welder was observed manually welding in the 3G (vertical) position utilizing a Shielded Metal Arc Welding (SMAW) with 1/8" diameter E7018H4R electrode and implementing Caltrans approved Welding Procedure Specification (WPS) ABF-WPS-D15-1040B. The joint being welded has a single V-groove butt joint with steel backing bar that has been removed and back gouged. The groove of the ground and gouged area of the

At OBG 10W/11W edge plate 'B' inside, QA randomly observed ABF/JV qualified welder Jorge Lopez continuing to perform fill pass to cover pass back welding on the Complete Joint Penetration (CJP) splice butt joint. The welder was observed manually welding in the 3G (vertical) position utilizing a Shielded Metal Arc Welding (SMAW) with 1/8" diameter E7018H4R electrode and implementing Caltrans approved Welding Procedure Specification (WPS) ABF-WPS-D15-1040B. The joint being welded has a single V-groove butt joint with steel backing bar that has been removed and back gouged. The groove of the ground and gouged area of the backing bar was also tested and passed using Magnetic Particle Testing (MT). During welding, ABF Quality Control (QC) William Sherwood was noted monitoring the welding parameters of the welder. At the end of the shift, cover pass SMAW welding was still continuing and should remain tomorrow.

At OBG 10E/11E LS1 longitudinal stiffener inside, ABF welder Hua Qiang Hwang was observed setting up welding equipment/Miller Proheat 35 Induction Heater System in preparation for his next welding location. QA and QC performed a joint fit up verification on the fit up of the joint to be welded. The root gap was noted 3mm wide and the alignment was noted 1.5mm which appears in compliance to the contract requirements. During the shift, the welder was also noted cleaning/grinding the bevel faces of the groove in preparation for the splice welding. There was no welding performed on the stiffener today.
